Annual Inspection

St Helen Without Parish Council

Sandleigh Road Play Area

Inspection Ref: 2769028

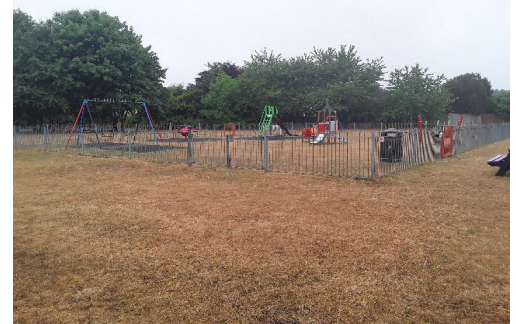
Item: Site General
Manufacturer: Not Applicable
Surface Type: N/A
Item Quantity: 1
Equipment Compliance: N/A
Surface Area Compliance: N/A

There is algae, silt or moss growth on the safety surface resulting in slippery conditions - Clean and treat appropriately

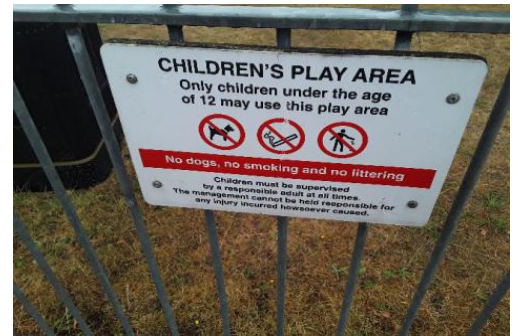
Item: Playground Sign
Manufacturer: Not Identified
Surface Type: N/A
Item Quantity: 1
Equipment Compliance: N/A
Surface Area Compliance: N/A

It is recommended that signage, with information including the site address, contact information for maintenance issues and emergency contact details are provided for the playground facility - Provide in accordance with the recommendations

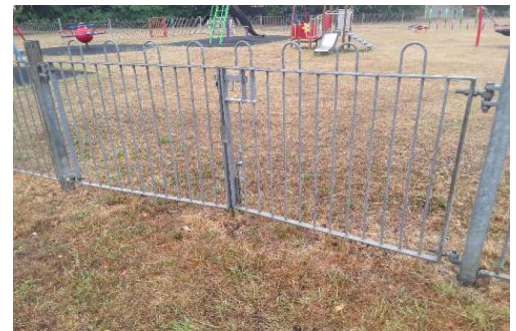
Item: Gate - Maintenance
Manufacturer: Not Identified
Surface Type: Grass
Item Quantity: 1
Equipment Compliance: N/A
Surface Area Compliance: N/A

The rubber buffer is missing from the latch plate - Replace rubber buffer

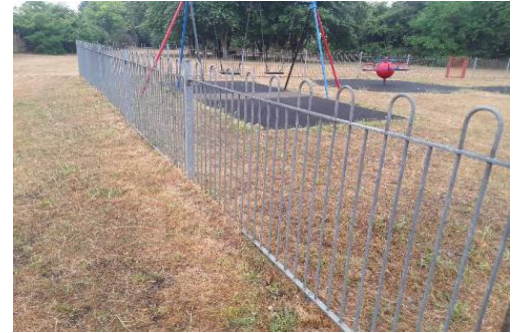
Item: Fence - Bow Top
Manufacturer: Not Identified
Surface Type: Grass
Item Quantity: 1
Equipment Compliance: N/A
Surface Area Compliance: N/A

There is minor damage to the fence sections - Monitor for any further deterioration and repair as required

A number of fixings have worked loose around the fencing - Secure all loose fixings

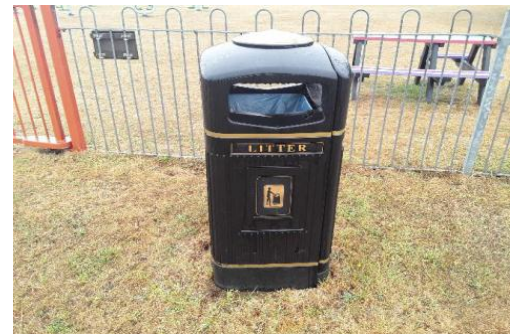
Item: Litter Bin
Manufacturer: Not Identified
Surface Type: Grass
Item Quantity: 1
Equipment Compliance: N/A
Surface Area Compliance: N/A

The item is slightly loose in its foundations - Monitor for any further deterioration and repair as required

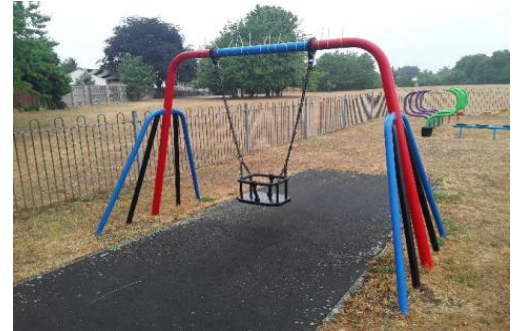
Item: 1 Bay 1 Seat (Cradle) - Type 1
Manufacturer: Wicksteed Playgrounds
Surface Type: Wet Pour
Item Quantity: 1
Equipment Compliance: No
Surface Area Compliance: Yes

The chain openings are in excess of the 8.6mm as recommended by BS EN 1176 - Monitor - No action given the risk assessment

The fixings have corroded - Replace all corroded fixings

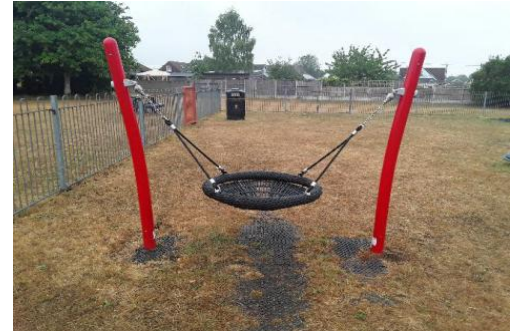
Item: Mini Basket Swing
Manufacturer: Hags
Surface Type: Grass Matrix Tiles
Item Quantity: 1
Equipment Compliance: No
Surface Area Compliance: Yes

The swing has been installed marginally too high which has resulted in the item being inspected to BS EN 1176 Part 2 - Monitor - No remedial work recommended

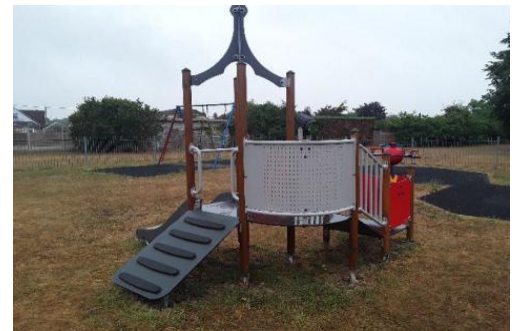
Item: Multi Play (Toddler)
Manufacturer: Hags
Surface Type: Grass Matrix Tiles
Item Quantity: 1
Equipment Compliance: No
Surface Area Compliance: Yes

The item has been installed marginally too high which has resulted in the platform height being in excess of 600mm (630mm) and technically, the height of the barriers are now insufficient to meet the requirements of BS EN 1176 Part 1. This is however a very low risk technicality and no remedial action is recommended as it has not affected the risk assessment of the item - No action given the risk assessment

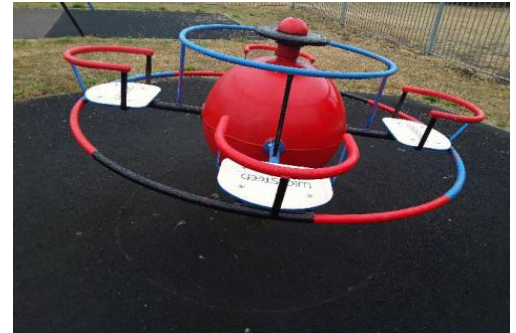
Item: Rotating Chairs
Manufacturer: Wicksteed Playgrounds
Surface Type: Wet Pour
Item Quantity: 1
Equipment Compliance: No
Surface Area Compliance: No

The item fails to meet the requirements of BS EN 1176 Part 1 4.2.7.2 for head and neck entrapment in the framework - Monitor - No action given the risk assessment

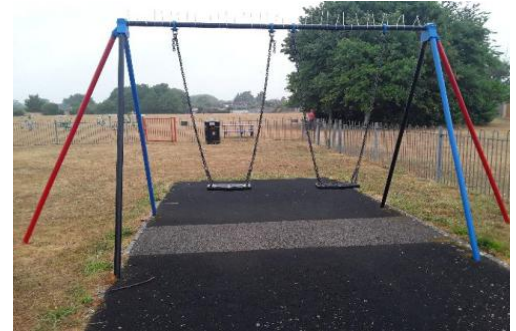
Item: 1 Bay 2 Seat (Flat)
Manufacturer: Wicksteed Playgrounds
Surface Type: Wet Pour
Item Quantity: 1
Equipment Compliance: No
Surface Area Compliance: Yes

The chain openings are in excess of the 8.6mm as recommended by BS EN 1176 - Monitor - No action given the risk assessment

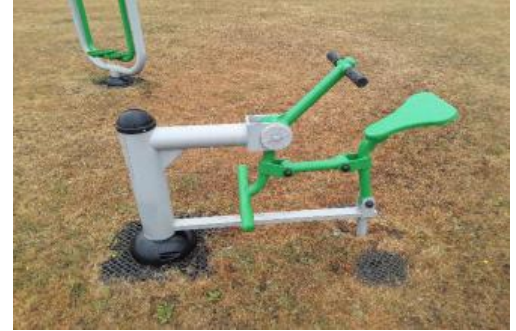
Item: Rider
Manufacturer: Caloo
Surface Type: Grass Matrix Tiles
Item Quantity: 1
Equipment Compliance: Yes
Surface Area Compliance: Yes

This item is satisfactory - no work required -

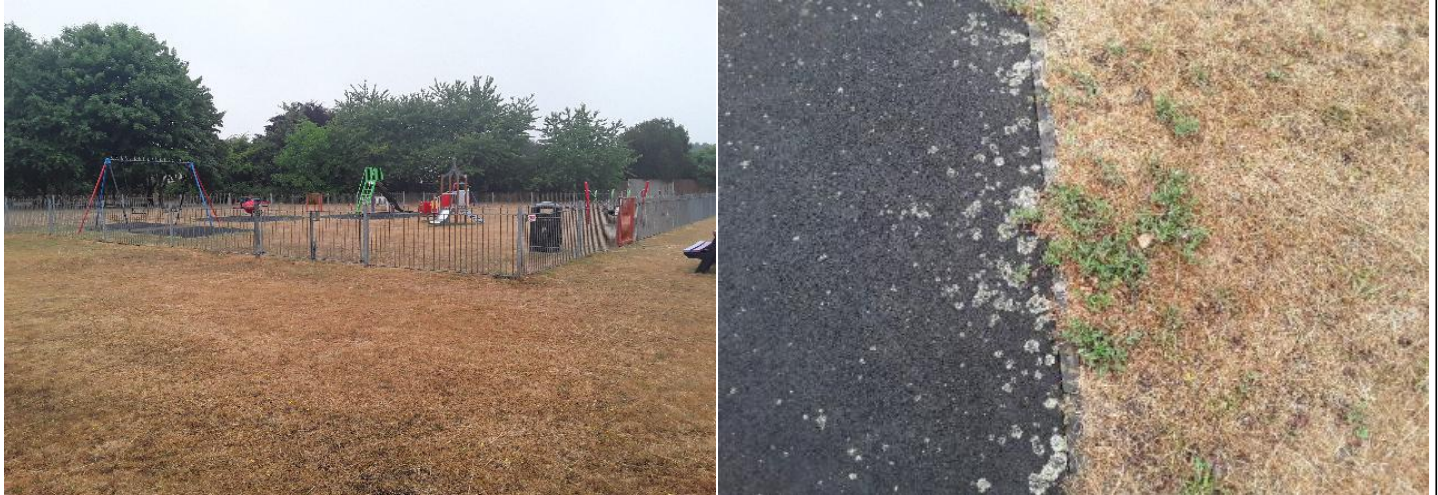
Finding: There is weed / vegetation growth on and around the surface
Action: Remove weed / vegetation growth

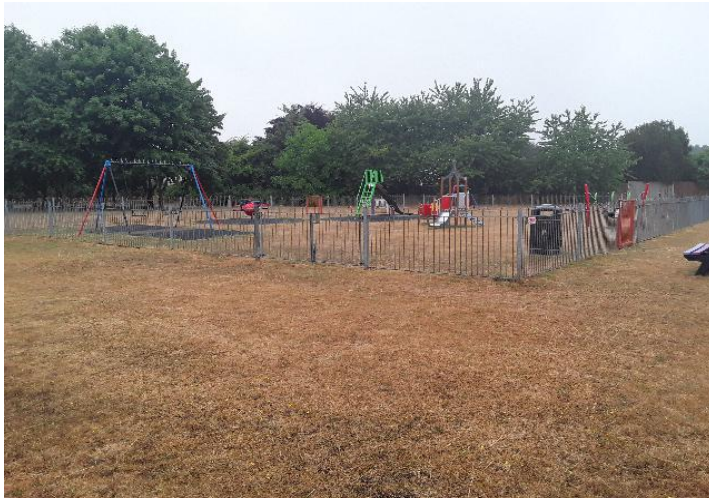
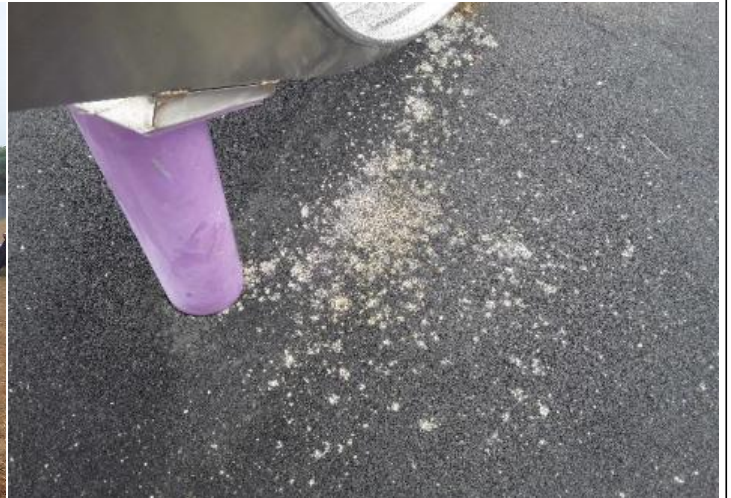
Finding: There is algae, silt or moss growth on the safety surface resulting in slippery conditions

Action: Clean and treat appropriately

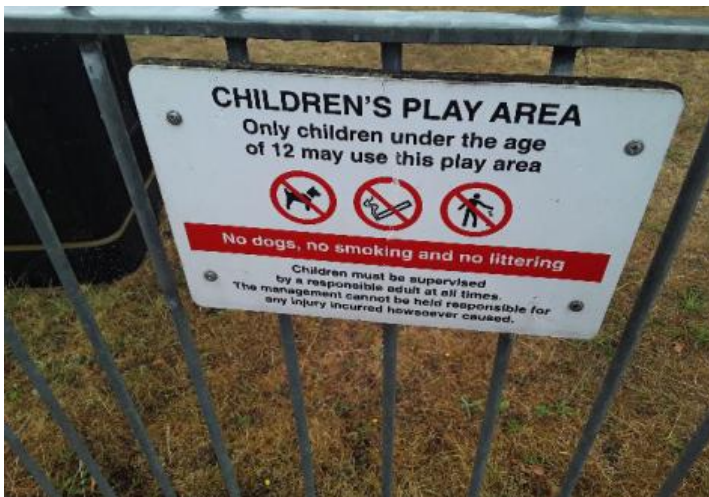
Finding: It is recommended that signage, with information including the site address, contact information for maintenance issues and emergency contact details are provided for the playground facility

Action: Provide in accordance with the recommendations

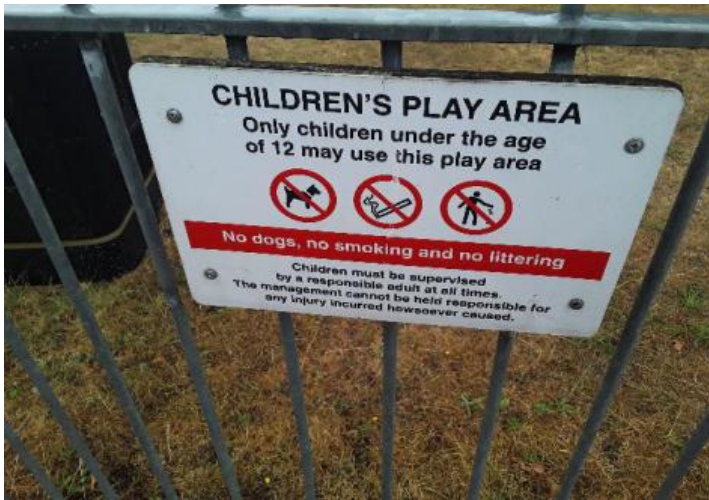
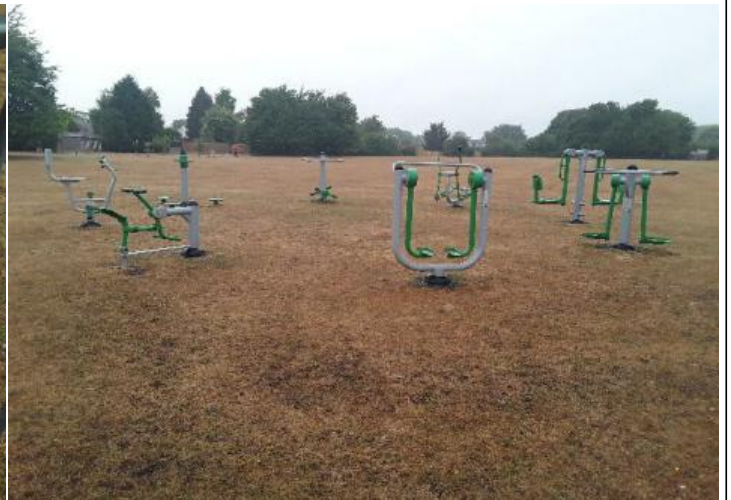
Finding: Signage should be provided for the outdoor fitness equipment in accordance with the requirements of BS EN 16630, key requirements of the sign include, but are not limited to, intended users, medical safety and emergency contact details
Action: Provide appropriate signage

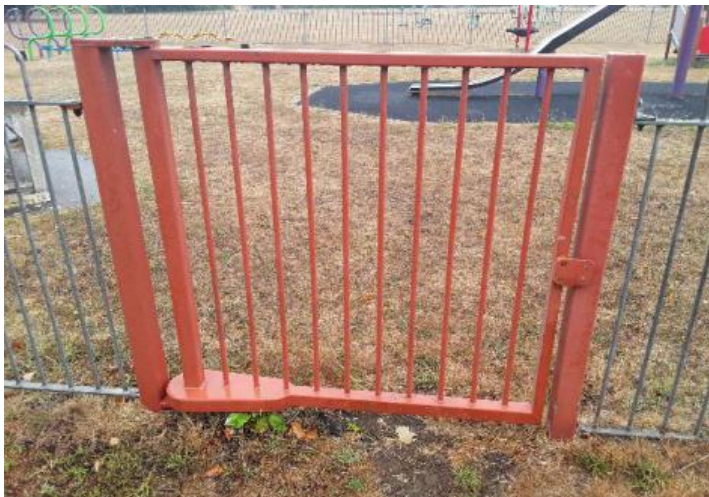
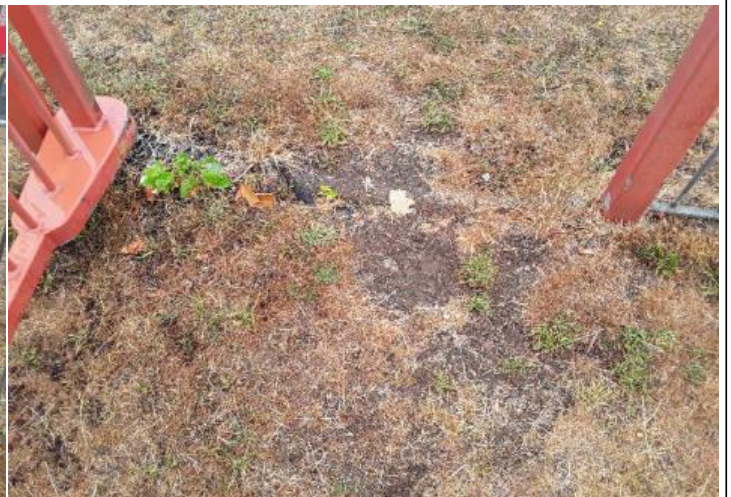
Finding: The grass mats are silted up, the soil is compacted and the area will become very slippery when the soil is wet.
Action: Reinstate as required

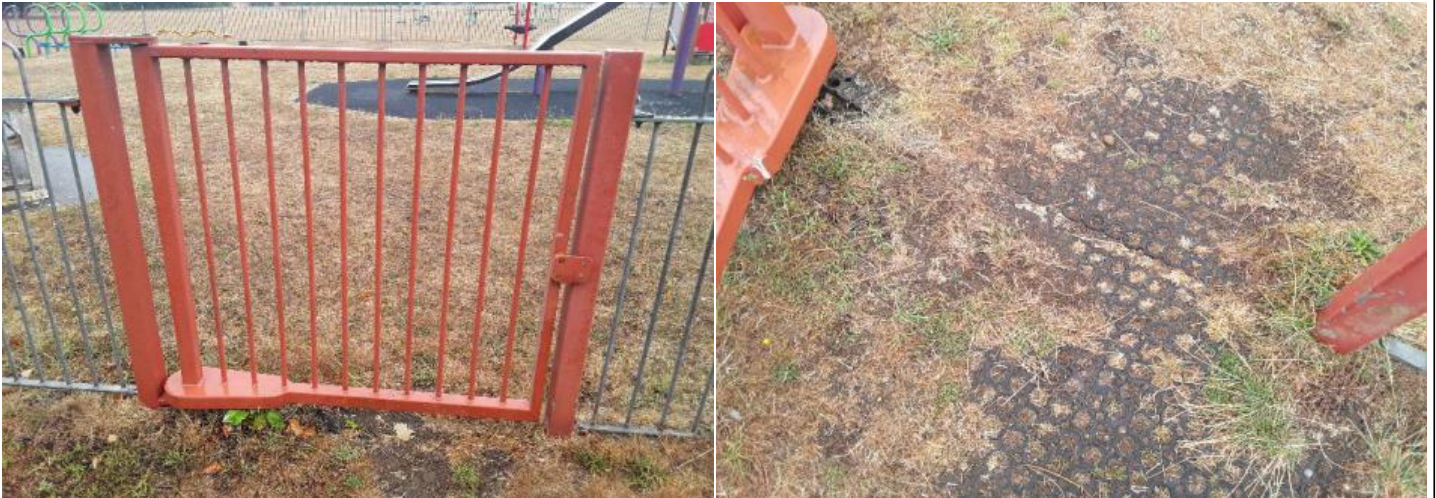
Finding: There are gaps opening between the grass mat tiles

Action: Provide additional ties or secure / reinstate surface tiles

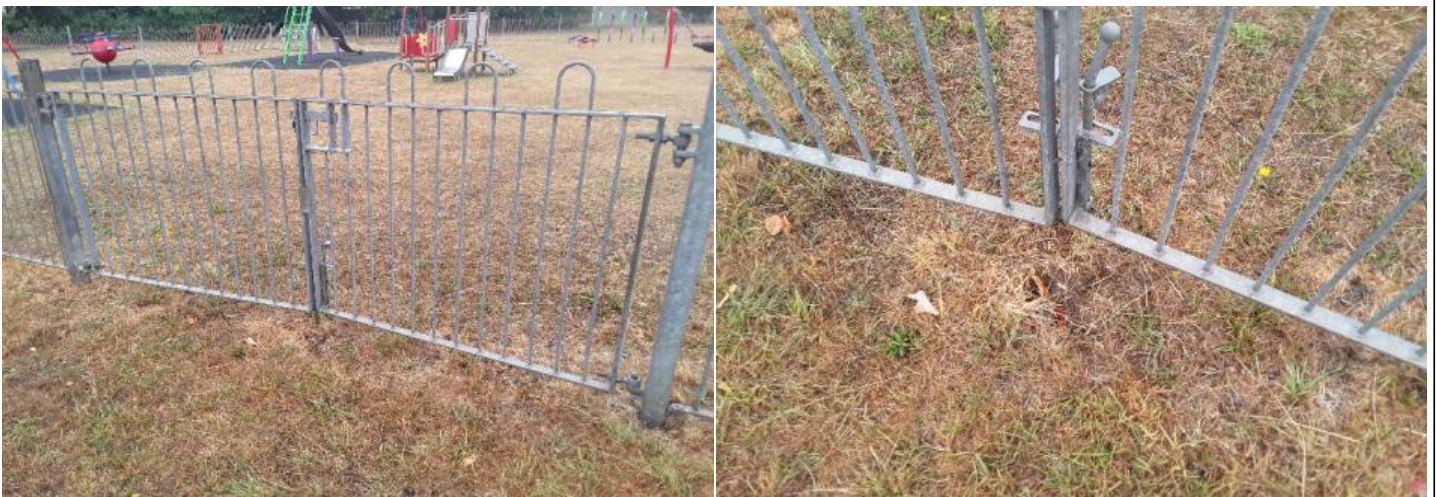
Finding: The gate has no drop bolt sleeves and/or drop bolts fitted

Action: Provide drop bolt sleeves and/or drop bolts

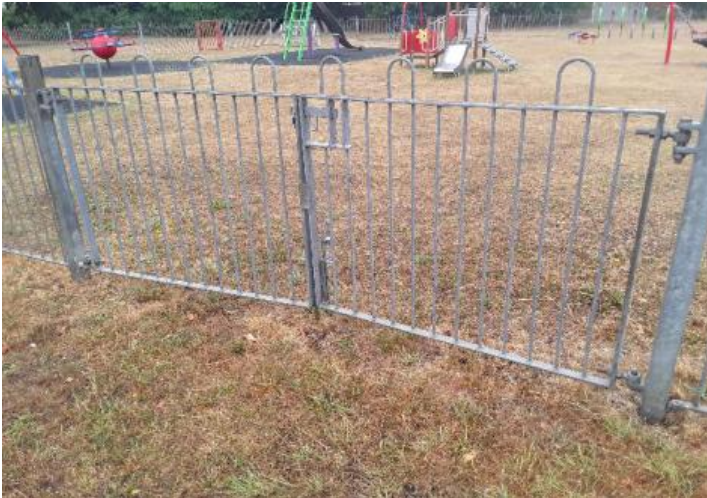
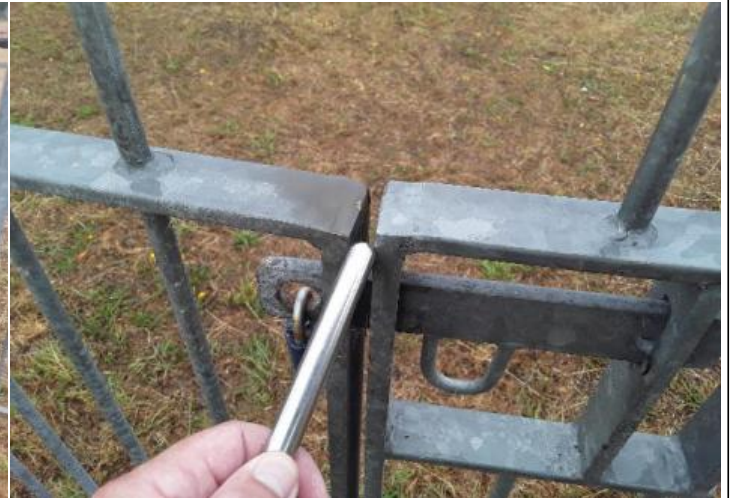
Finding: There are openings that are less than 12mm that could trap or crush fingers

Action: Provide a 12mm gap throughout full range of motion at both sides of gate

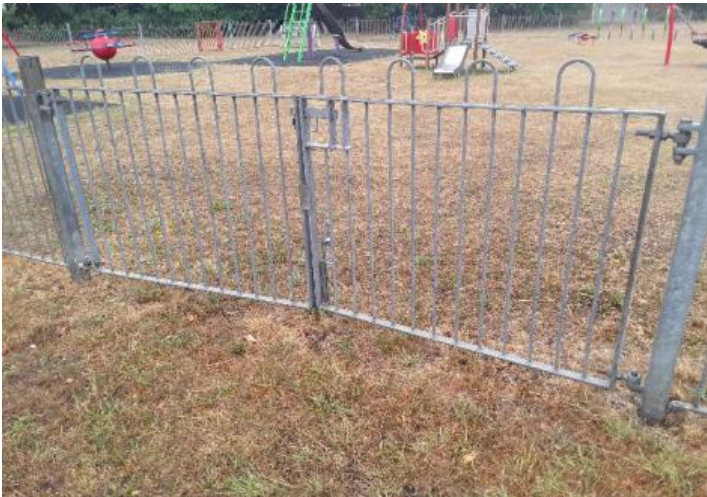
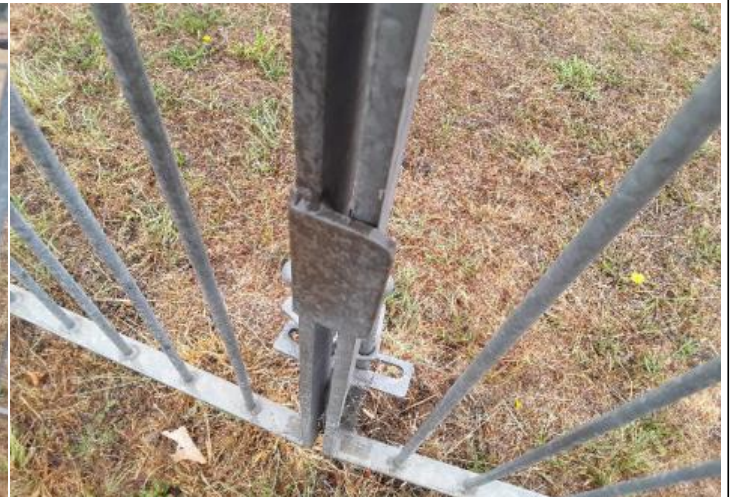
Finding: The rubber buffer is missing from the latch plate

Action: Replace rubber buffer

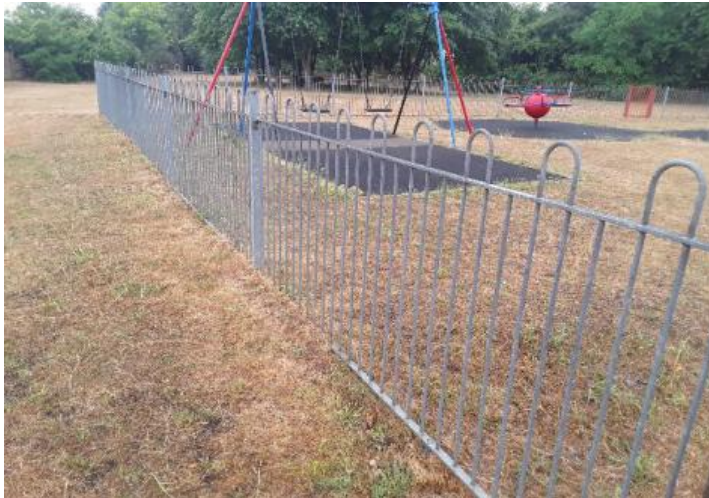
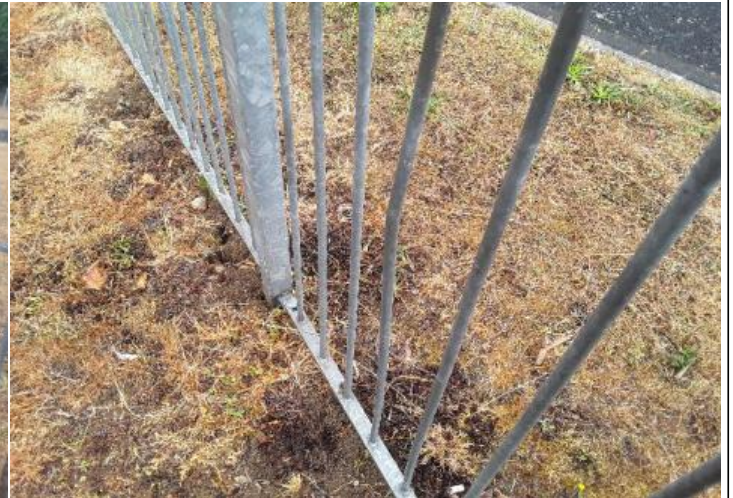
Finding: There is minor damage to the fence sections

Action: Monitor for any further deterioration and repair as required

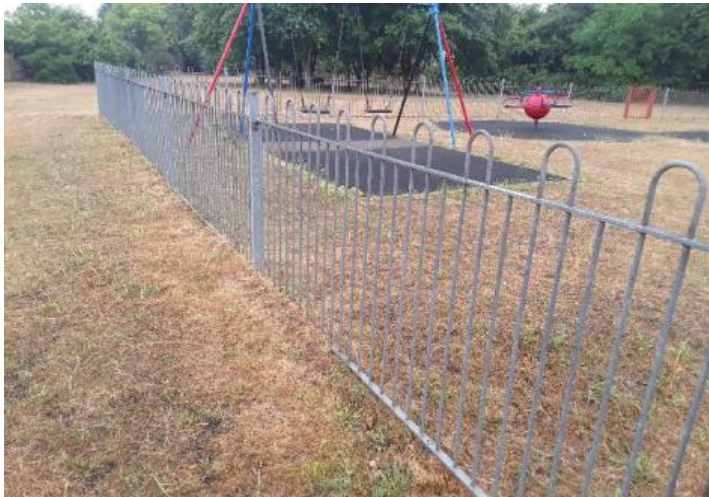
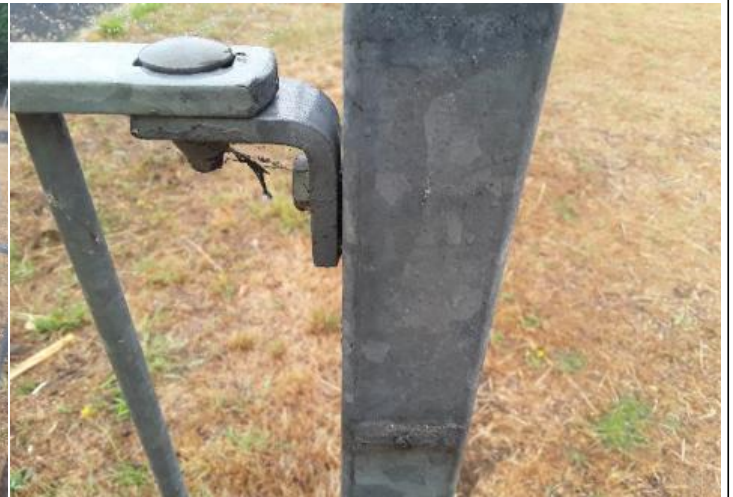
Finding: A number of fixings have worked loose around the fencing

Action: Secure all loose fixings

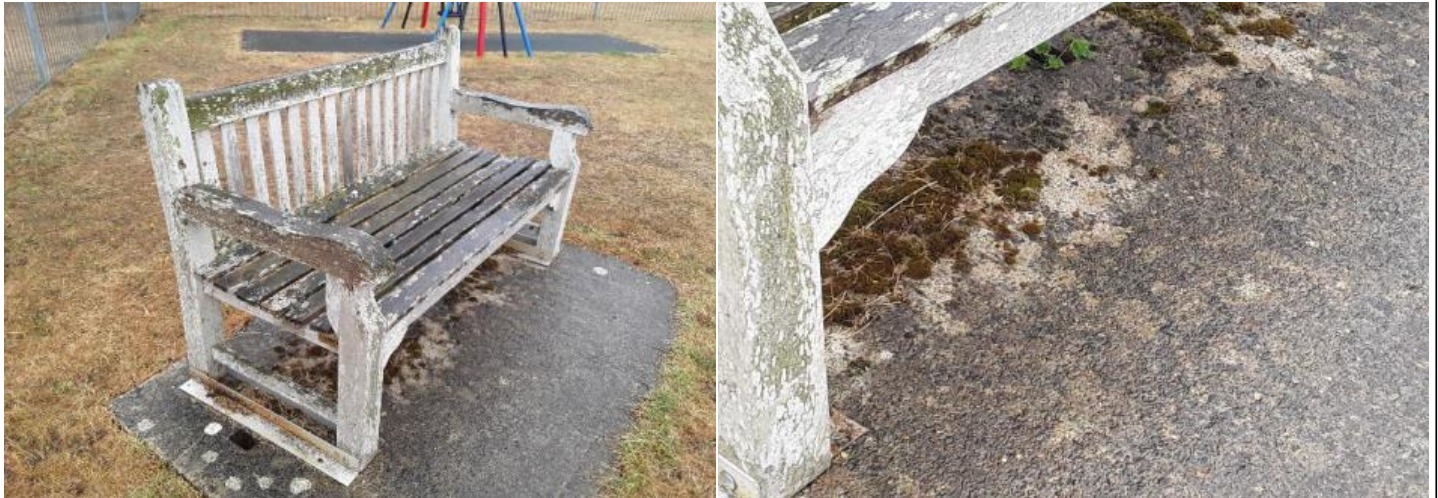
Finding: There is algae, silt or moss growth on the surface under the bench
Action: Clean and treat appropriately

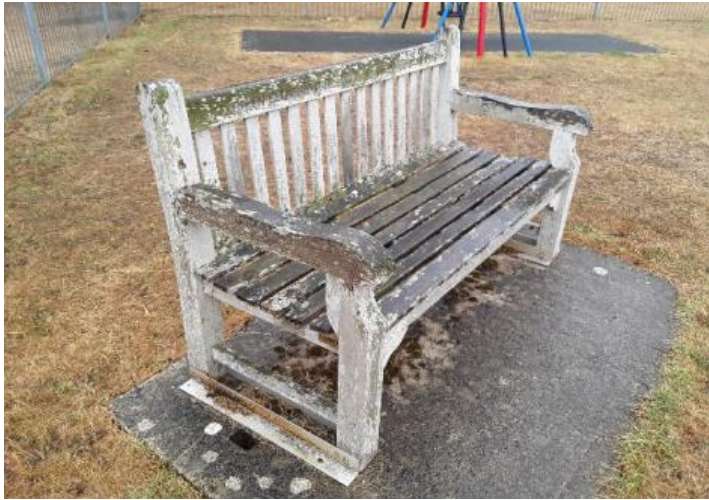
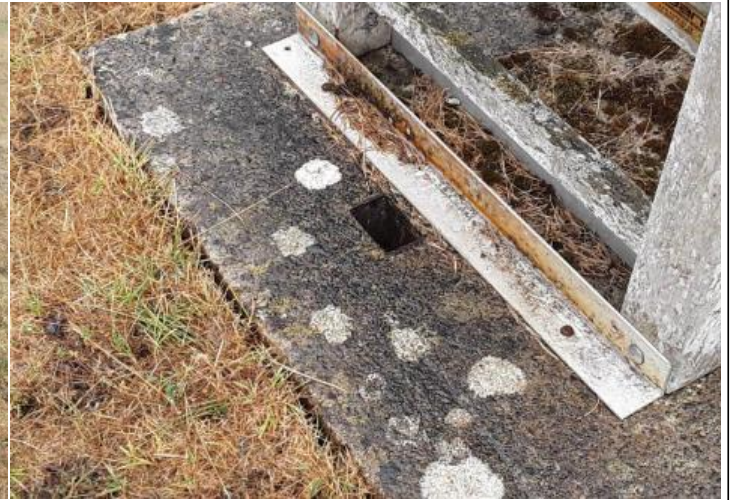
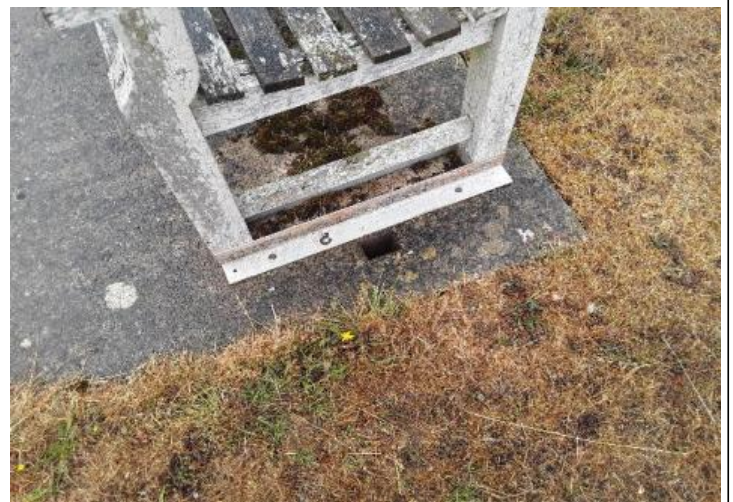
Finding: There are redundant sockets in the concrete base **Action:** Reinstate to provide a uniform surface

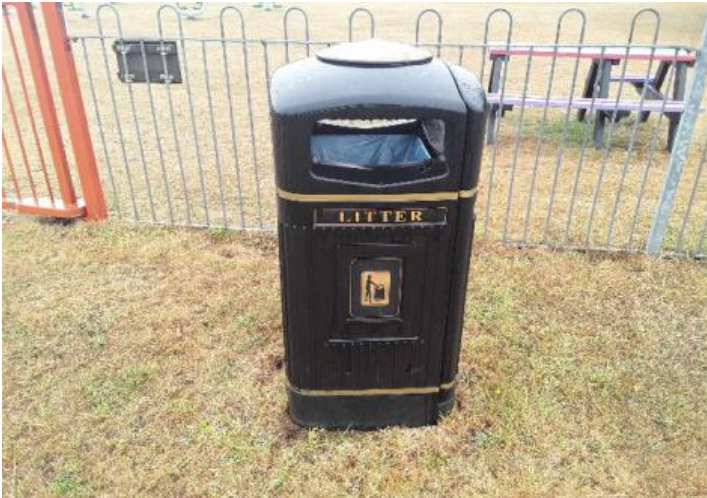
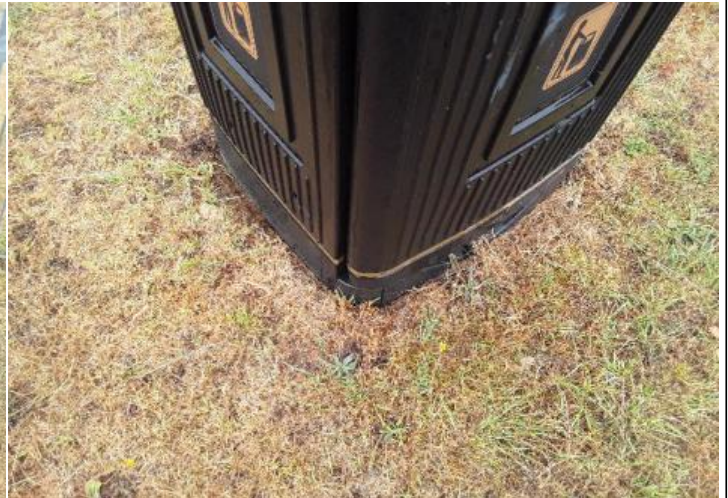
Finding: The item is slightly loose in its foundations

Action: Monitor for any further deterioration and repair as required

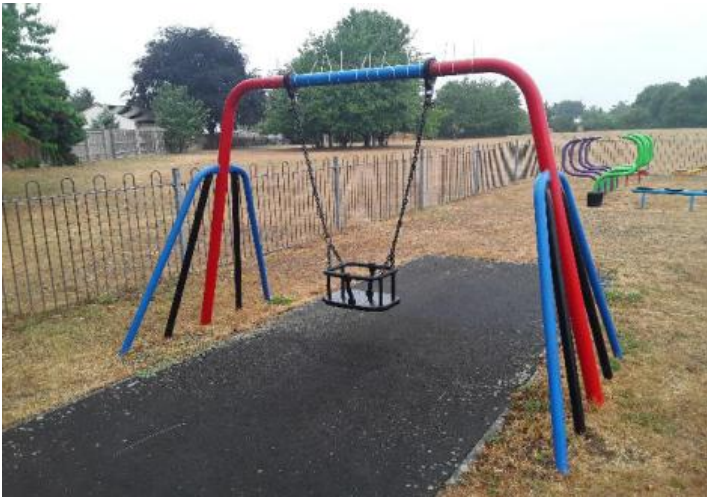
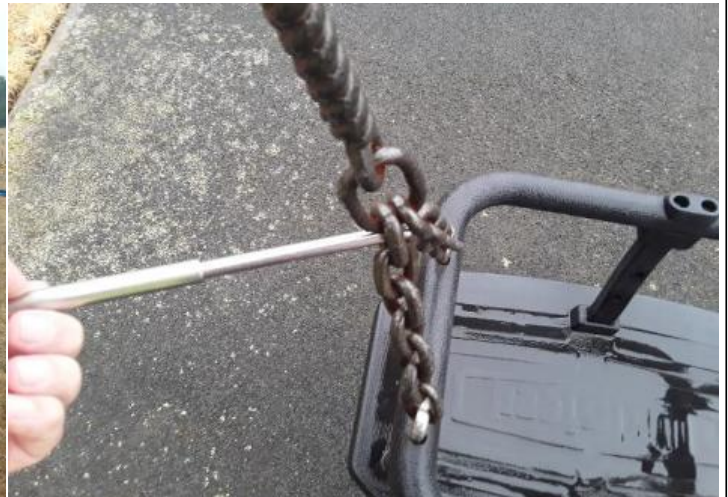
Finding: The chain openings are in excess of the 8.6mm as recommended by BS EN 1176

Action: Monitor - No action given the risk assessment

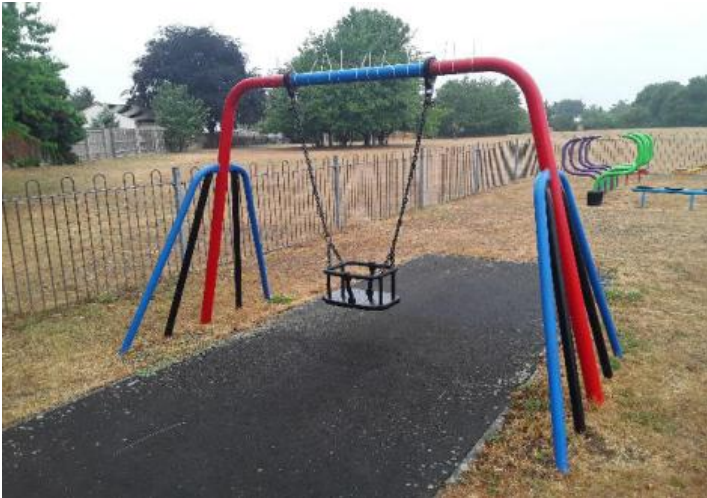
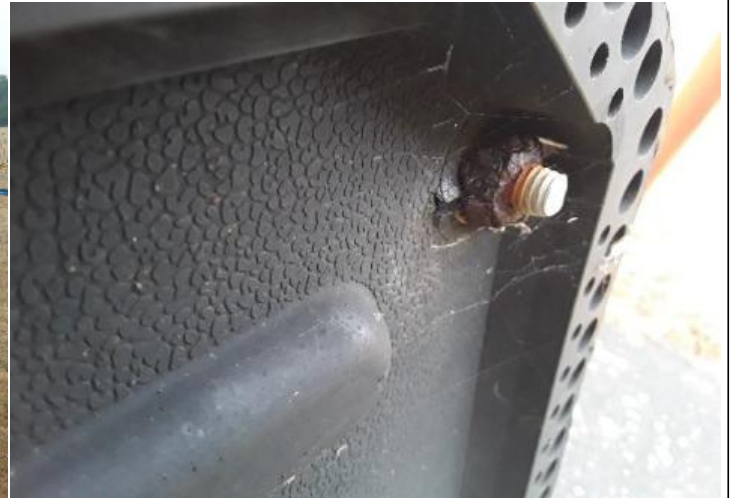
Finding: The fixings have corroded

Action: Replace all corroded fixings

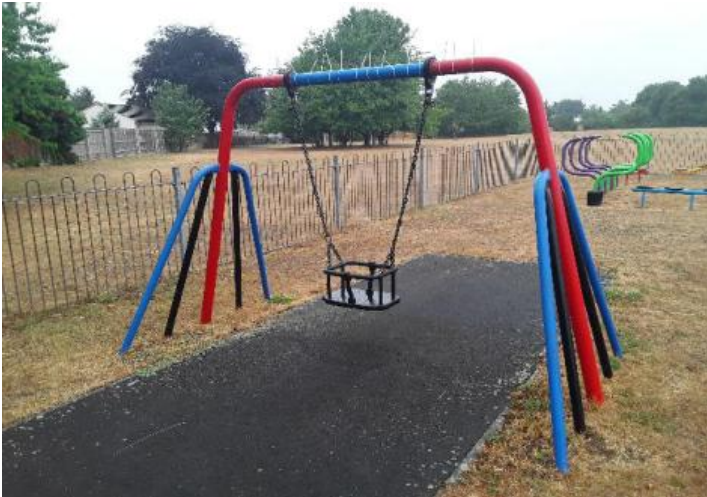
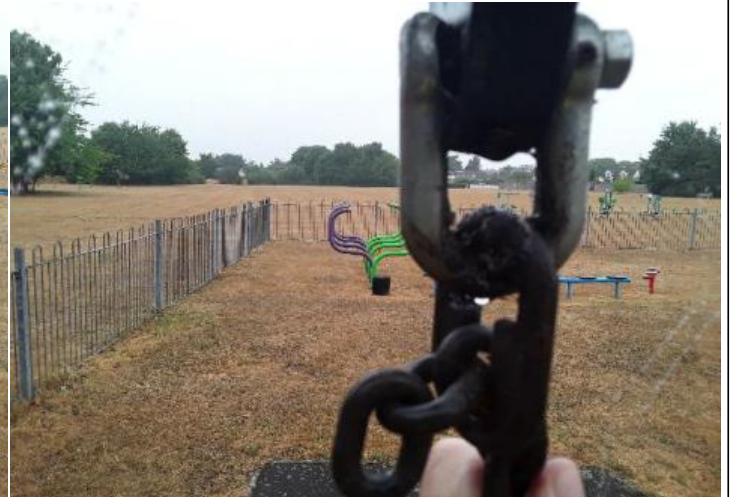
Finding: There is excessive grease on the shackles

Action: Remove the excess grease

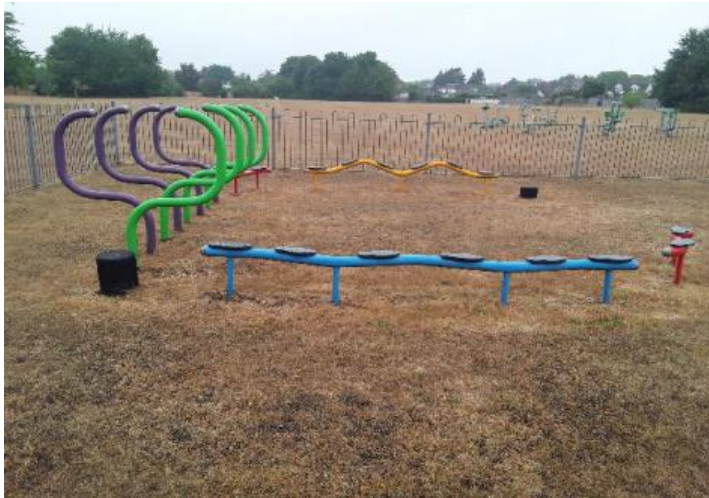
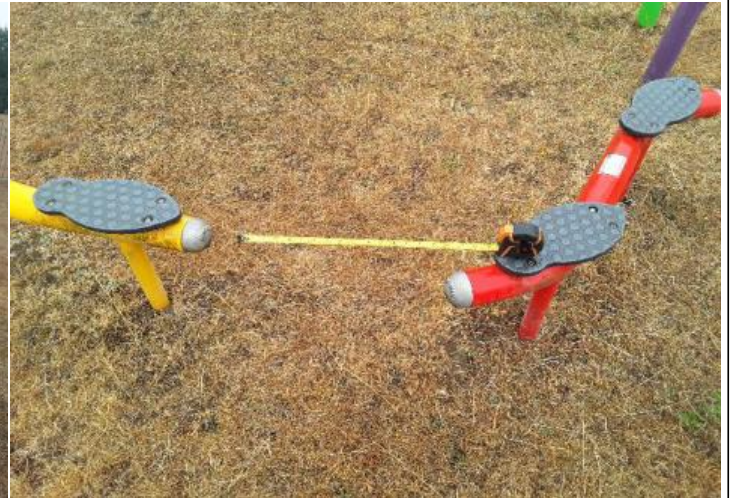
Finding: The step between the items is quite large and users may not be able to complete the step without touching ground, the items could therefore be considered to be within the falling space of each other, however the intention of the play activity continuity is easily apparent and foreseeable to the user

Action: Monitor - No action given the risk assessment

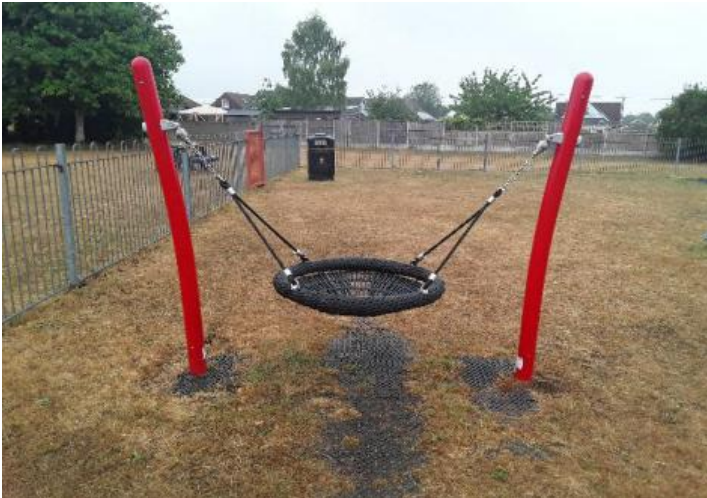
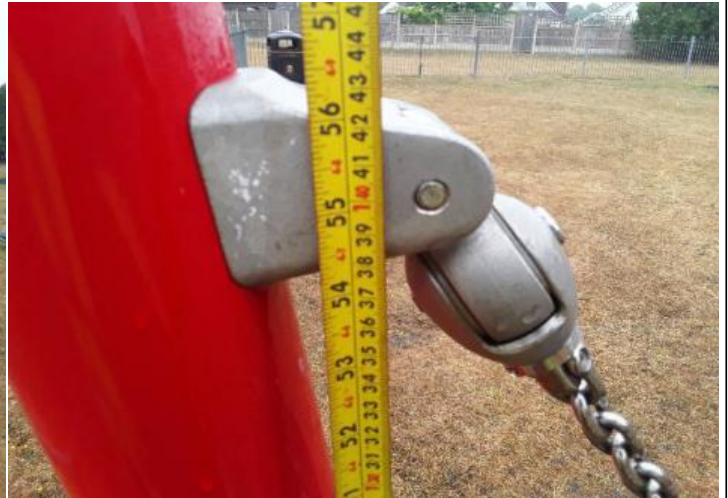
Finding: The swing has been installed marginally too high which has resulted in the item being inspected to BS EN 1176 Part 2

Action: Monitor - No remedial work recommended

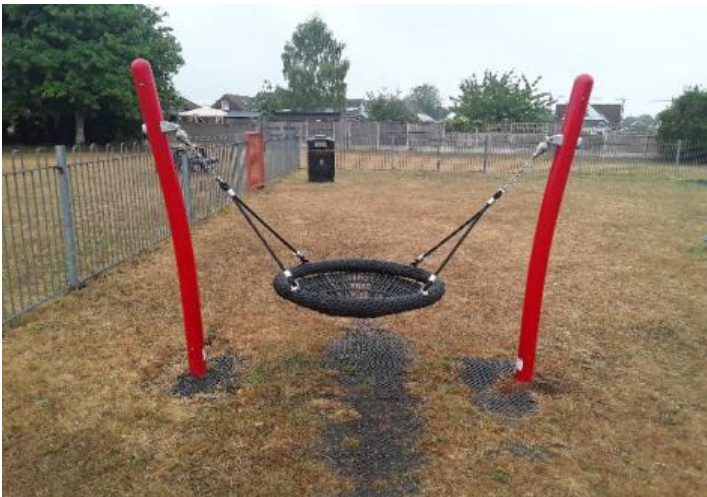
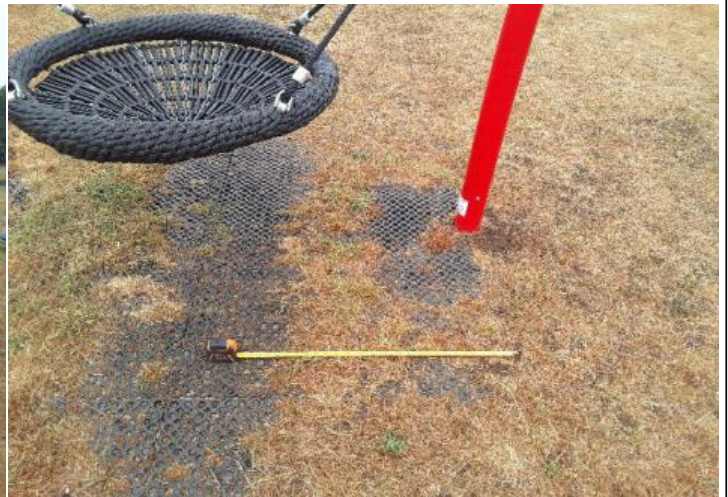
Finding: The seat/s is / are too close to the frame as defined in BS EN 1176 Part 2

Action: Monitor - No action given the risk assessment

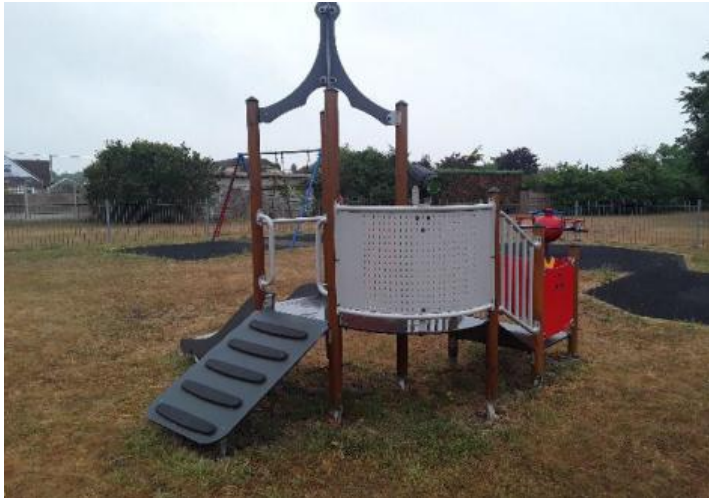
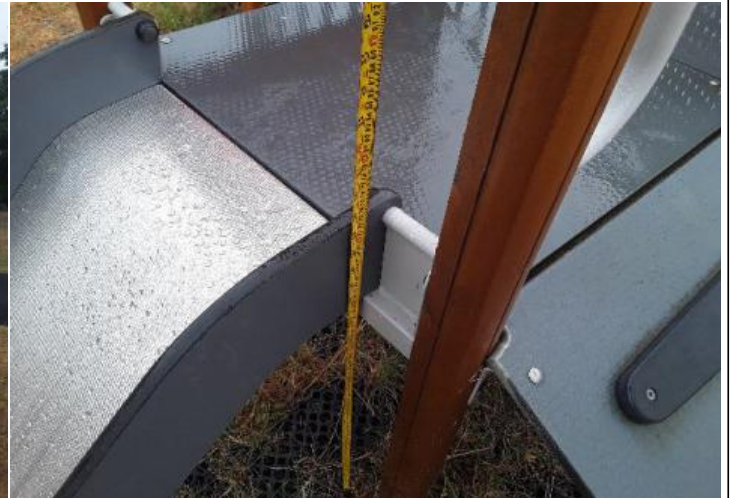
Finding: The item has been installed marginally too high which has resulted in the platform height being in excess of 600mm (630mm) and technically, the height of the barriers are now insufficient to meet the requirements of BS EN 1176 Part 1. This is however a very low risk technicality and no remedial action is recommended as it has not affected the risk assessment of the item

Action: No action given the risk assessment

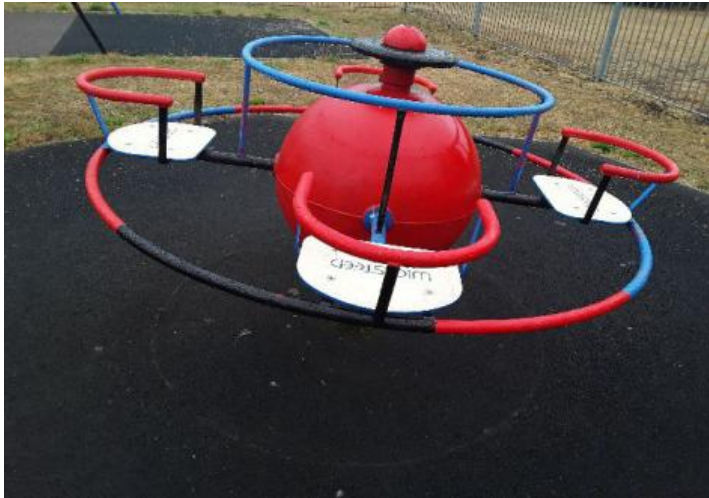
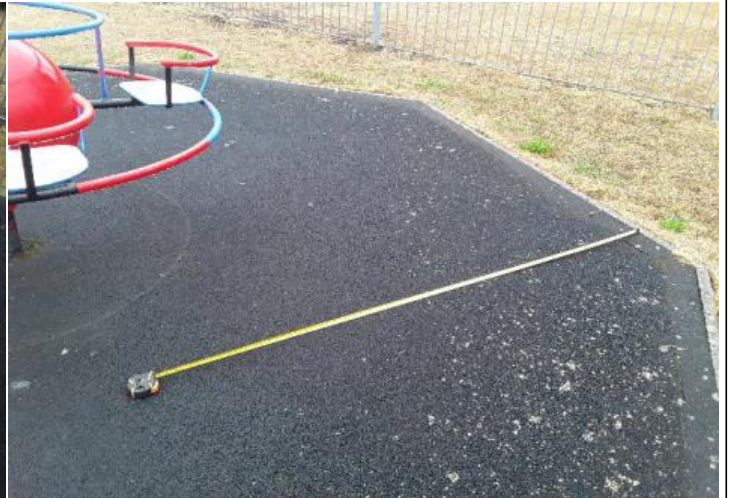
Finding: The surfacing dimensions are short and do not meet with the requirements of the current applicable standard

Action: Monitor - No action given the risk assessment

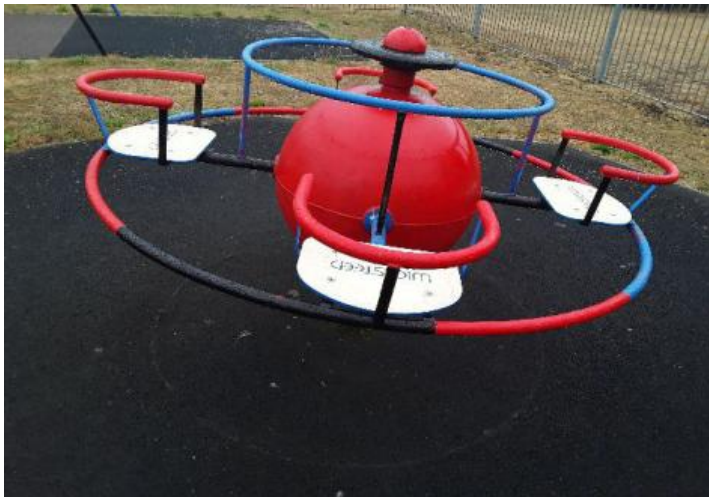
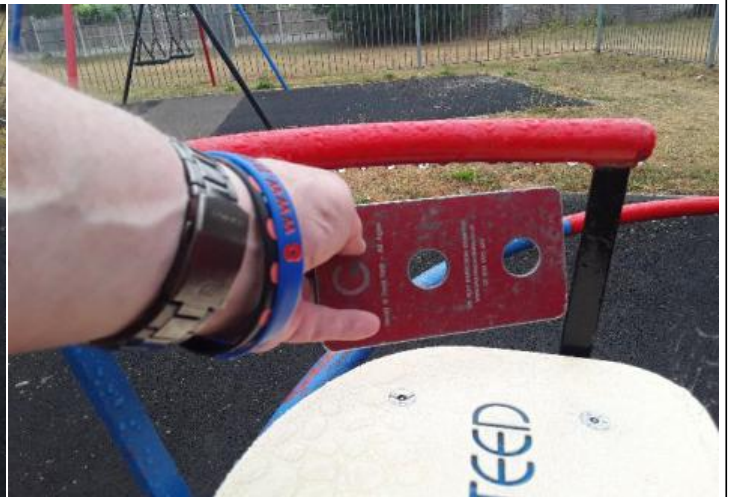
Finding: The item fails to meet the requirements of BS EN 1176 Part 1 4.2.7.2 for head and neck entrapment in the framework

Action: Monitor - No action given the risk assessment

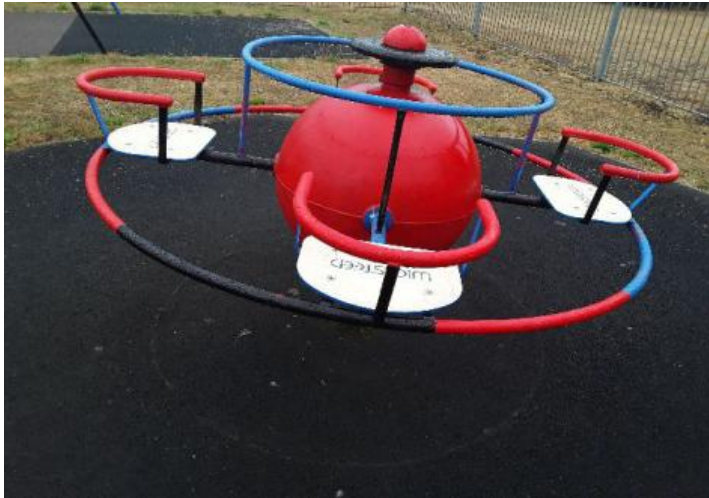
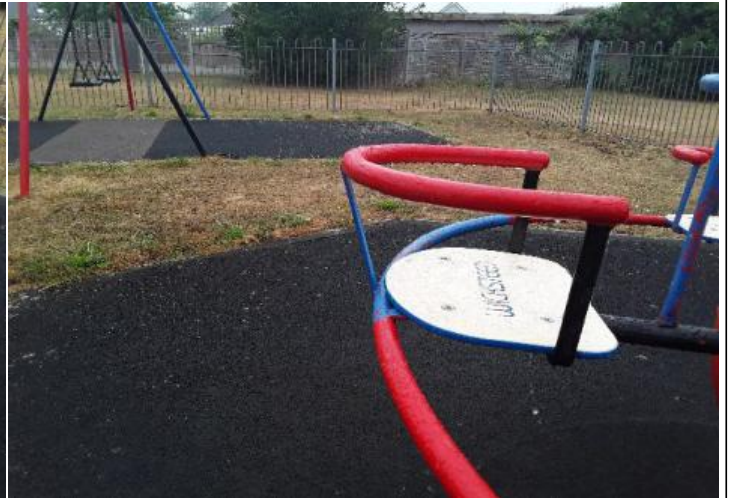
Finding: Parts of the steel structure protrude beyond the protected elements of the seat and fail to meet the requirements of BS EN 1176 Part 5

Parts of the steel structure protrude beyond the protected elements of the seat and fail to meet the requirements of BS EN 1176 Part 5 - Monitor - No action given the risk assessment

Action: Monitor - No action given the risk assessment

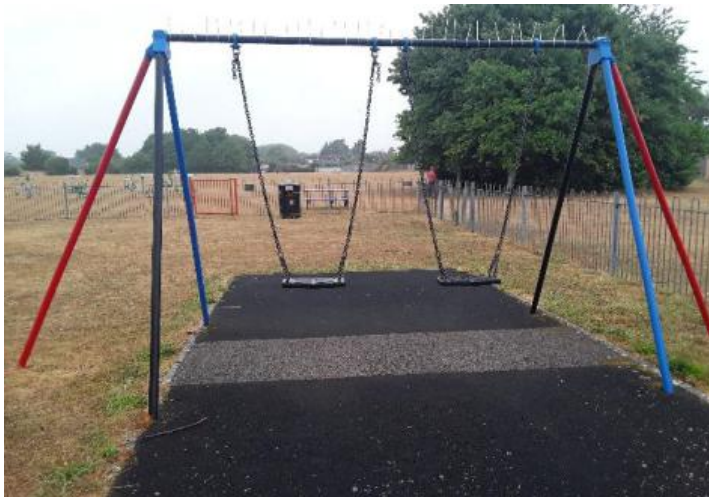
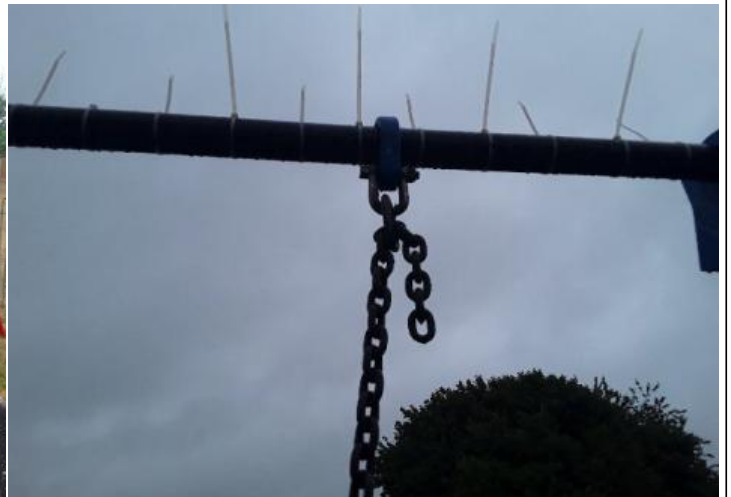
Finding: There are excessive chain tails

Action: Cut back excessive chain links

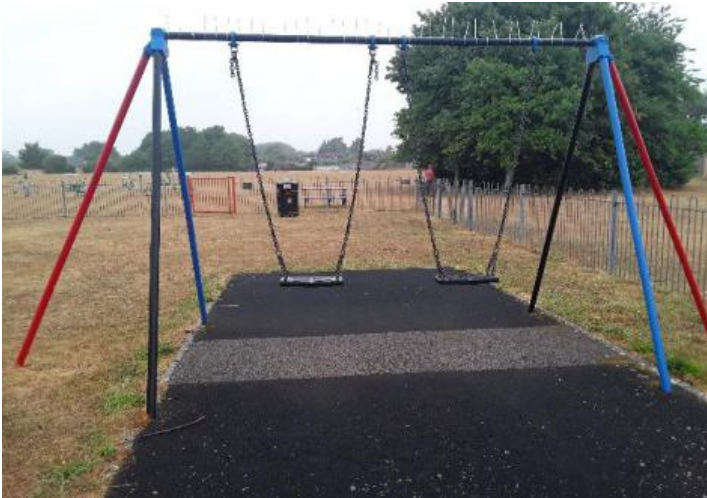
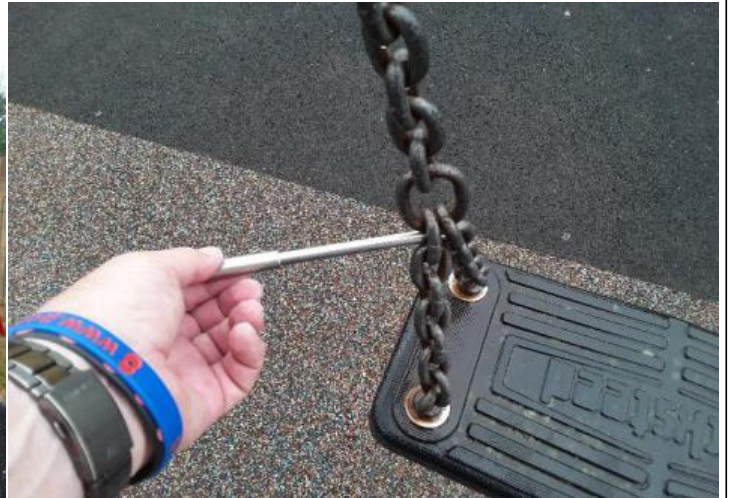
Finding: The chain openings are in excess of the 8.6mm as recommended by BS EN 1176
Action: Monitor - No action given the risk assessment
