Annual Inspection

St Helen Without Parish Council

Sandleigh Road Play Area

Inspection Ref: 2769028

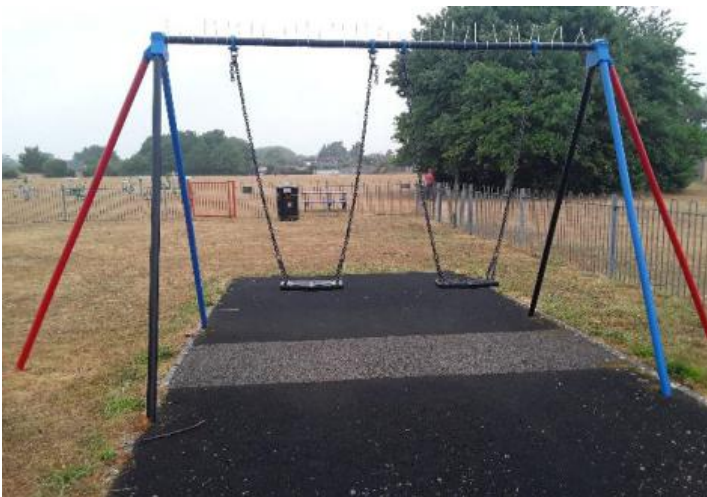
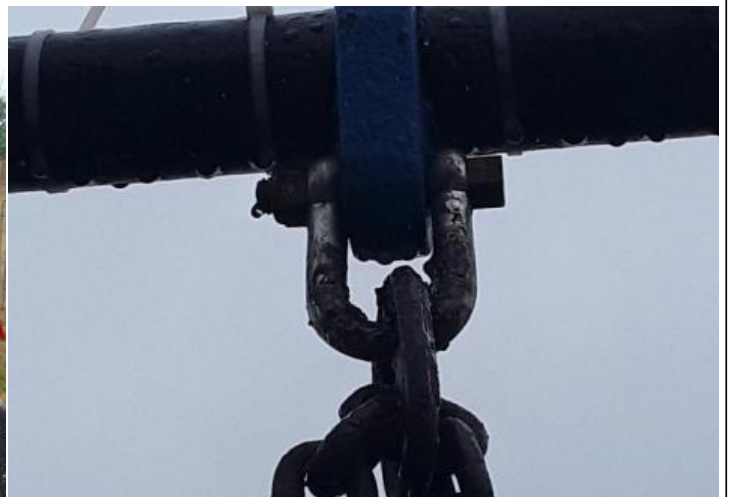
Finding: There is excessive grease on the shackles
Action: Remove the excess grease

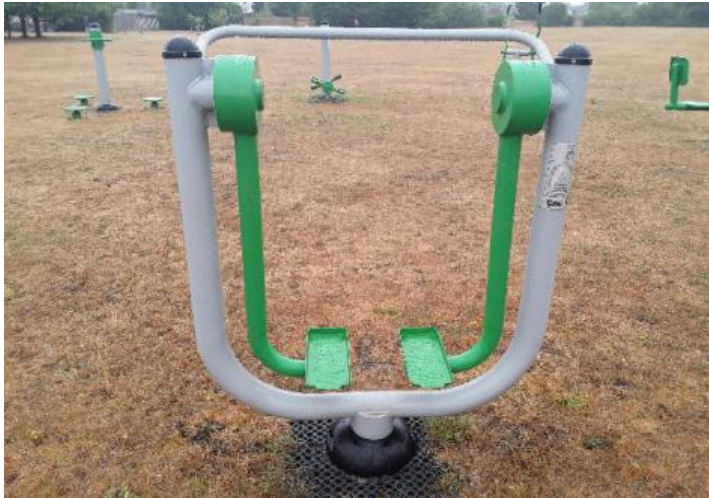
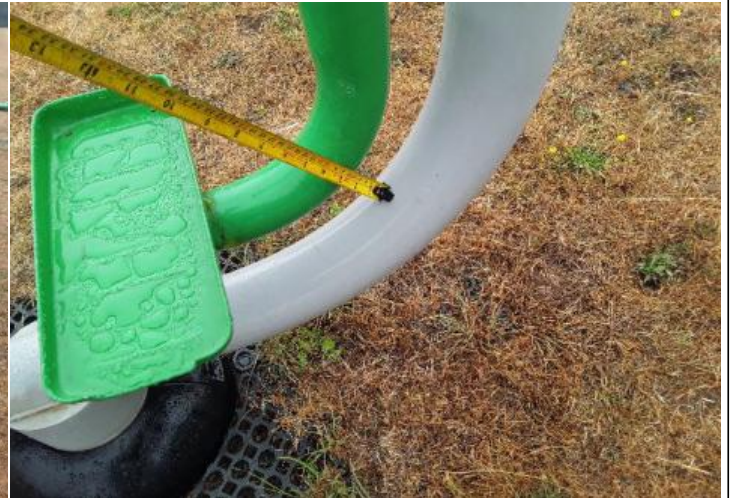
Finding: There are gaps between 8 and 60mm creating a potential crush/shear point in contravention of the requirements of BS EN 16630

Action: Monitor - No action given the risk assessment

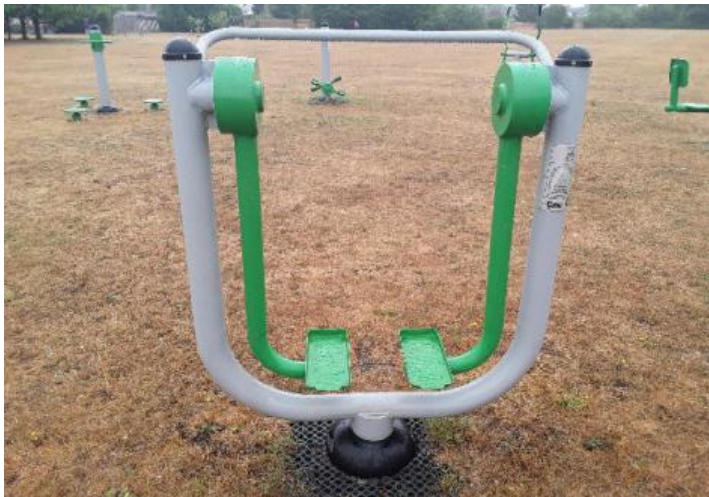
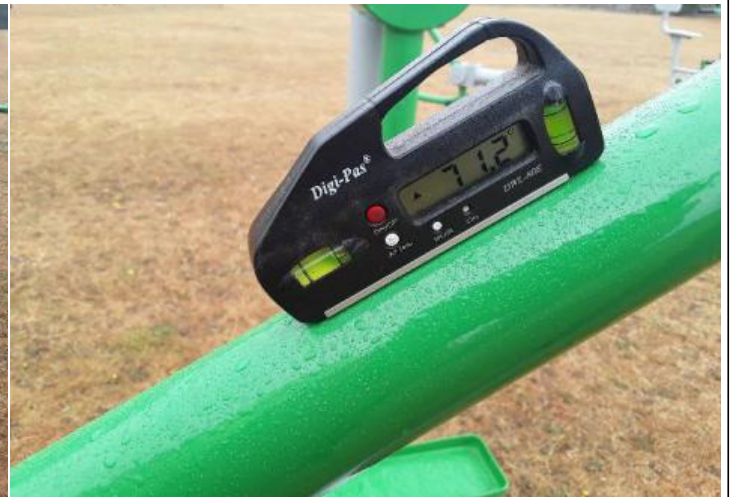
Finding: The swinging movement of the item exceeds the maximum 55 degrees from the vertical required by BS EN 16630

Action: Monitor - No action given the risk assessment

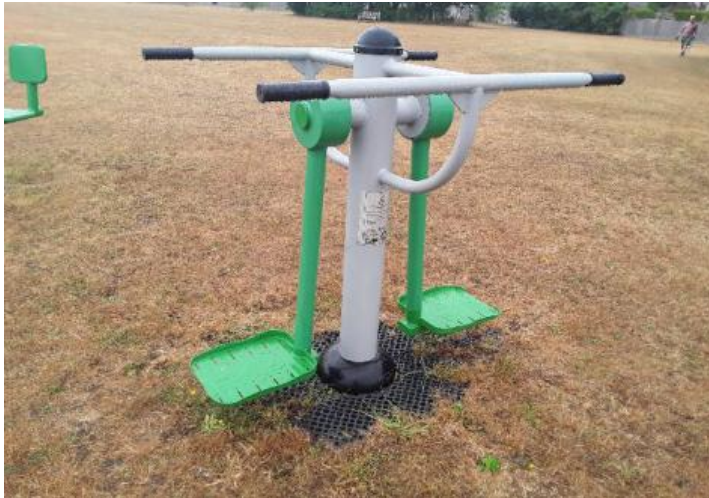
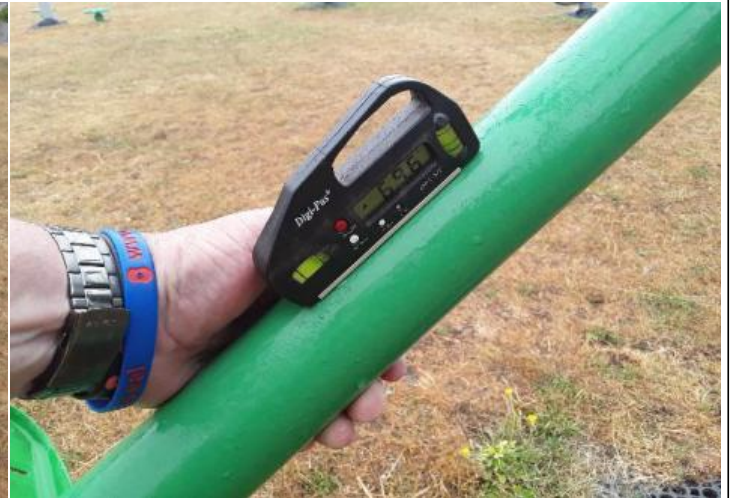
Finding: The swinging movement of the item exceeds the maximum 55 degrees from the vertical required by BS EN 16630

Action: Monitor - No action given the risk assessment
